EMpower System Troubleshooting Guide

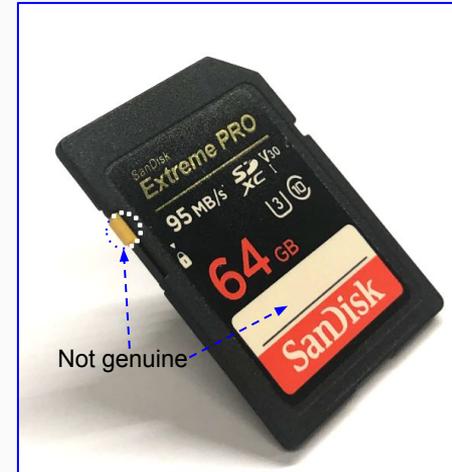
SD ■■■■■■■■

REC ERRORS

SD CARD IS DAMAGED
CORRUPTED OR
THE WRONG FORMAT

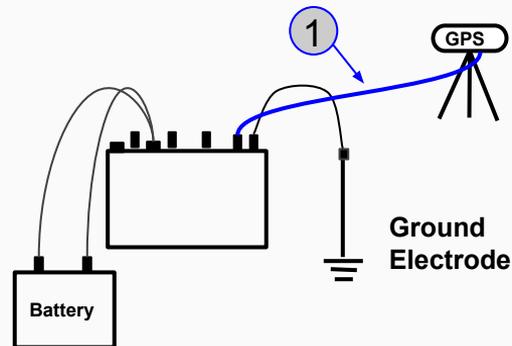
2

Use the SD button to navigate in the on-screen display

Starting Acquiring GPS Ready

1. Reposition the antenna for a clear view of the sky
 - Check the condition of the GPS antenna cable, and replace it if damaged
 - Ensure that there is a clear line-of-sight between the GPS antenna and the sky
 - Test with an antenna and cable from another receiver
2. Wait until the Power button turns blue

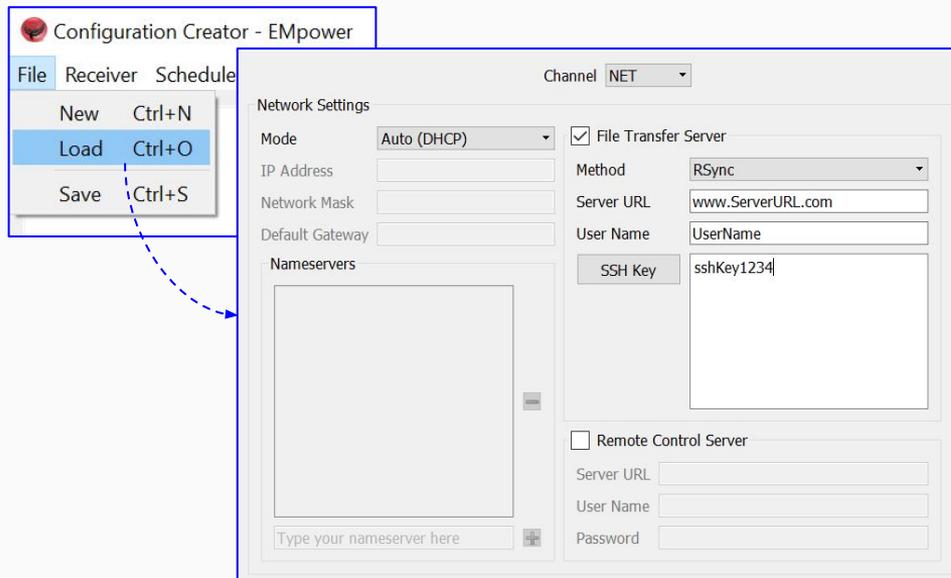
SD ■ ■

```
REC ERRORS
-----
INVALID CONFIG
NETWORK
SETTINGS INVALID
```

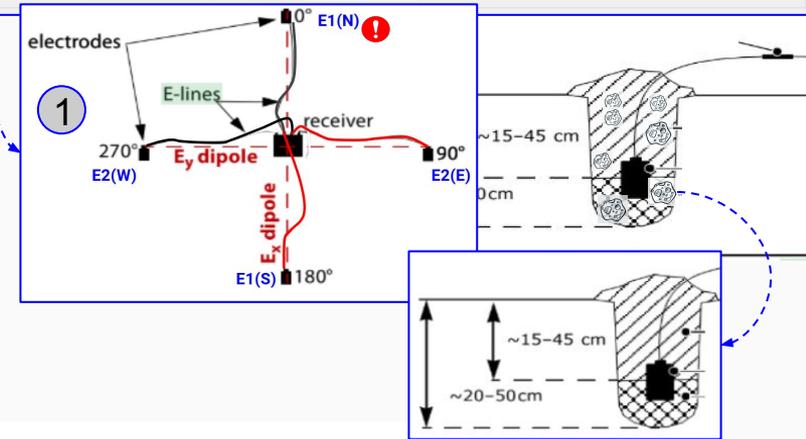
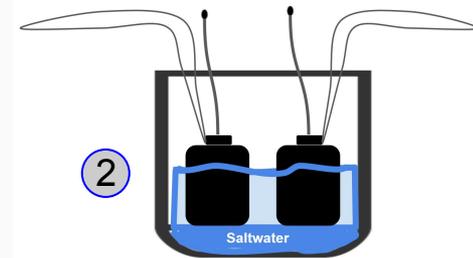
Channel	Distance (m) to GND		Polarity	Resistance (Ω)		Gain	LPF [Hz]	DC [V]
	(+) N / E	(-) S / W		(+) N / E	(-) S / W			
E1	50.00	50.00	<input type="checkbox"/> Inverted	175831	175789	4 x 1 = x4	17800	-0.012
E2	50.00	50.00	<input type="checkbox"/> Inverted	175634	175609	4 x 1 = x4	17800	0.012

E Azimuth: 0° External Filter: None

1. Verify the setup
 - Make sure the electrode is sitting on a conductive surface (remove rocks)
2. If the problem persists, set the electrodes upright in a container with a few centimeters of salt water or another ion-rich solution and measure the resistance between any pair of electrodes
 - The resistance should be $<100 \Omega$
 - Measure the DC potential between each electrodes pair
 - The self-potential should be $<10 \text{ mV}$
 - If the last two points are not in this range the electrodes could be damaged or noisy, and need to be replaced

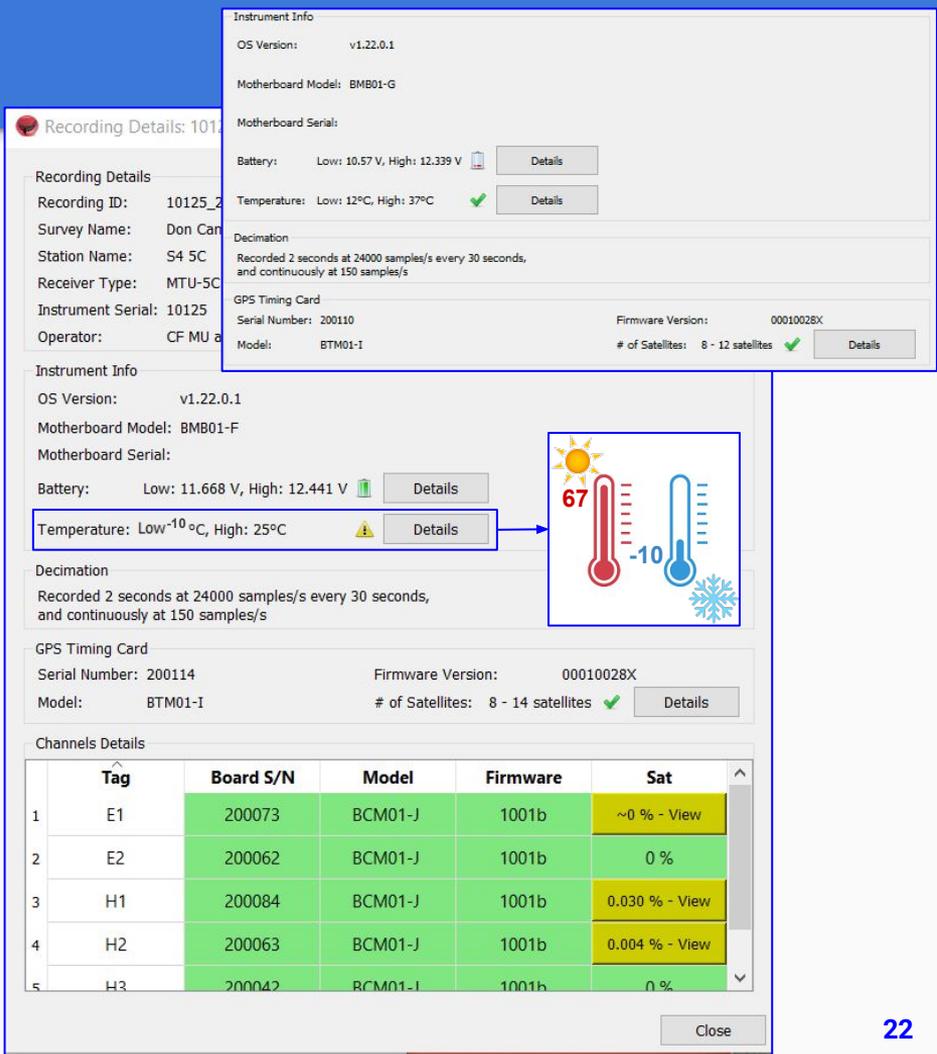
The screenshot displays the 'Recording Details' and 'Instrument Info' sections of a monitoring application. A blue box highlights a temperature warning: 'Temperature: Low: -10 °C, High: 25°C' with a yellow warning icon. An inset image shows a thermometer with a red liquid level at 67 and a blue liquid level at -10, with a sun icon above and a snowflake below. The 'Recording Details' section includes: Recording ID: 10125_2, Survey Name: Don Can, Station Name: S4 5C, Receiver Type: MTU-5C, Instrument Serial: 10125, Operator: CF MU a. The 'Instrument Info' section includes: OS Version: v1.22.0.1, Motherboard Model: BMB01-F, Motherboard Serial: [redacted], Battery: Low: 11.668 V, High: 12.441 V, Temperature: Low: -10 °C, High: 25°C, Decimation: Recorded 2 seconds at 24000 samples/s every 30 seconds, and continuously at 150 samples/s, GPS Timing Card Serial Number: 200114, Model: BTM01-I, Firmware Version: 00010028X, # of Satellites: 8 - 14 satellites. The 'Channels Details' table is shown below:

Tag	Board S/N	Model	Firmware	Sat
1	E1	200073	BCM01-J	1001b	~0 % - View
2	E2	200062	BCM01-J	1001b	0 %
3	H1	200084	BCM01-J	1001b	0.030 % - View
4	H2	200063	BCM01-J	1001b	0.004 % - View
5	H3	200042	BCM01-J	1001b	0 %

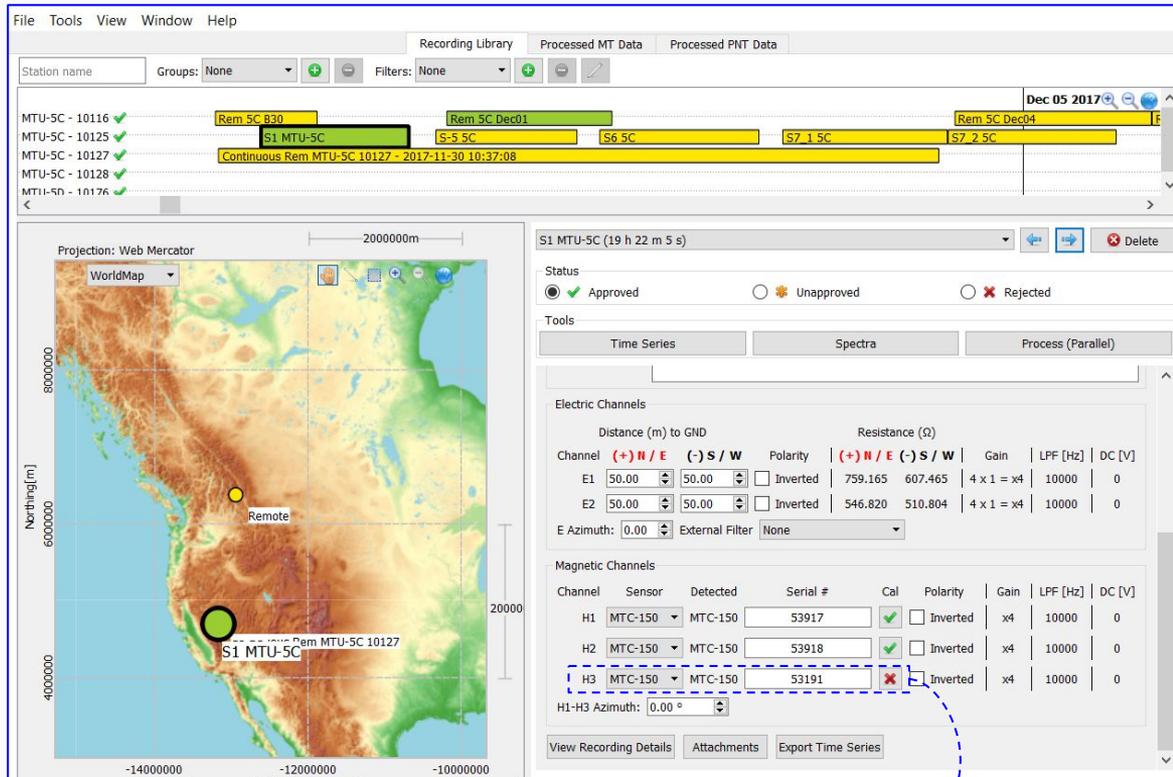
The screenshot shows a software interface with a menu bar (File, Tools, View, Window, Help) and tabs for Recording Library, Processed MT Data, and Processed PNT Data. A table lists recording stations with columns for Station name, Groups, Filters, and various recording parameters. Below the table is a map showing the location of the recording site, 'Remote', with a yellow dot. A green circle on the map highlights the location of 'S1 MTU-5C'. To the right of the map is a detailed view of the 'S1 MTU-5C (19 h 22 m 5 s)' recording. This view includes a 'Status' section with radio buttons for 'Approved', 'Unapproved', and 'Rejected'. Below that are 'Tools' for 'Time Series', 'Spectra', and 'Process (Parallel)'. The 'Electric Channels' section contains a table with columns for Channel, Distance (m) to GND, Resistance (Ω), Polarity, Gain, LPF [Hz], and DC [V]. The 'Magnetic Channels' section contains a table with columns for Channel, Sensor, Detected, Serial #, Cal, Polarity, Gain, LPF [Hz], and DC [V]. In the 'Magnetic Channels' table, channel H3 has a red X in the 'Cal' column, indicating a missing calibration file. A dashed blue box highlights this red X, and a callout box points to it with the text 'No matching calibration found'.

Channel	Sensor	Detected	Serial #	Cal	Polarity	Gain	LPF [Hz]	DC [V]
H1	MTC-150	MTC-150	53917	✓	<input type="checkbox"/> Inverted	x4	10000	0
H2	MTC-150	MTC-150	53918	✓	<input type="checkbox"/> Inverted	x4	10000	0
H3	MTC-150	MTC-150	53191	✗	<input type="checkbox"/> Inverted	x4	10000	0

No matching calibration found

If a red X is displayed in the **Cal** column of a magnetic channel, the calibration file for that sensor serial number has not been found

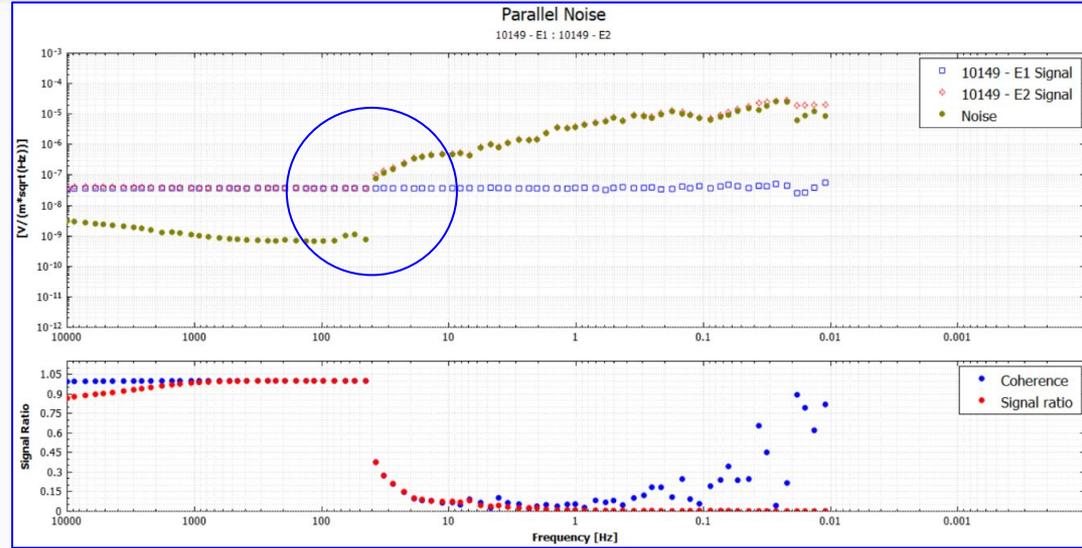
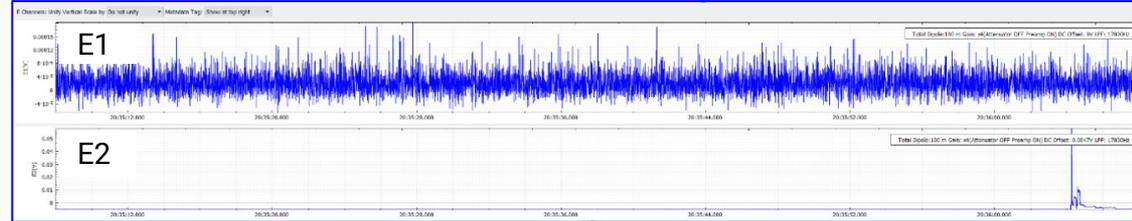
This problem could be caused when something touches the receiver E-line binding post during the recording process, review the Time Series and find the E-line affected.
